# PROJECT: CBFH

## PROGRESS REPORT

Date 7/26/2024

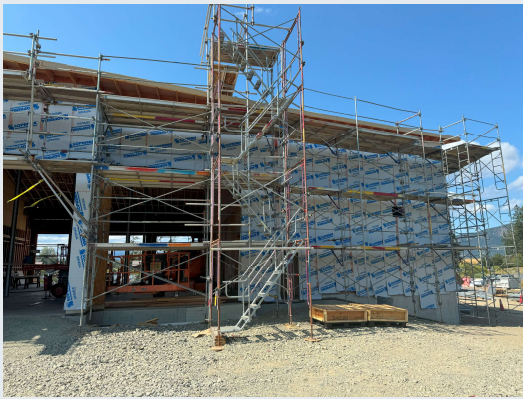
Wall membrane progressing East

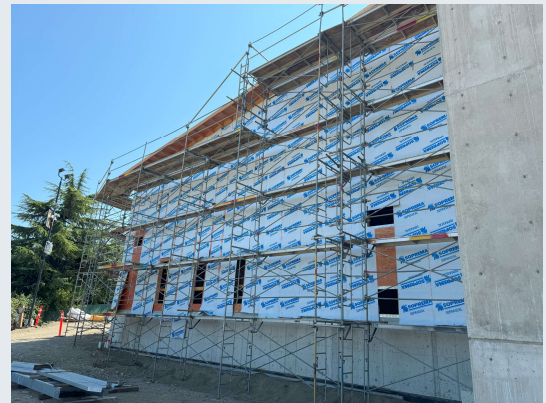
Wall membrane progressing North

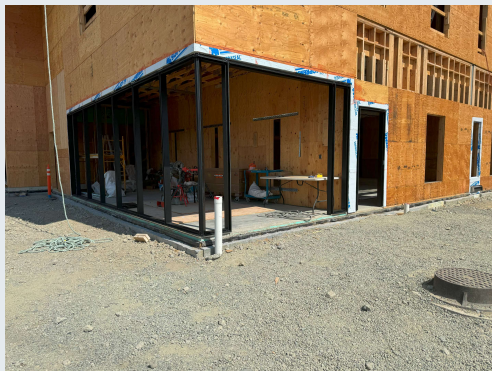
Aluminum frames and vinyl window mockup progressing

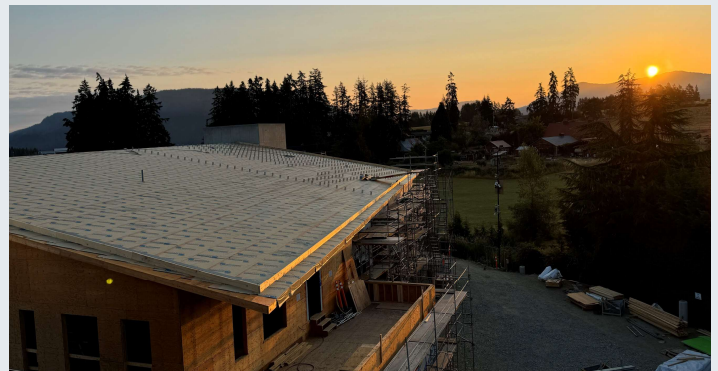
Roof VB complete / steel beam in / insulation clips started

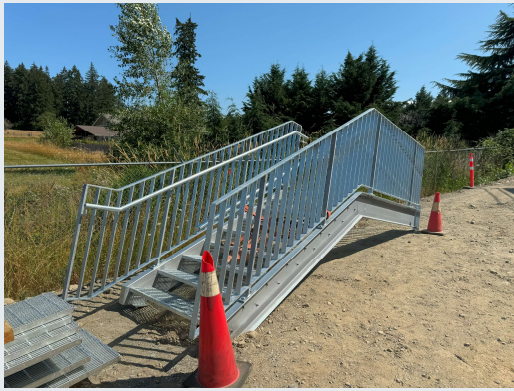
Hose tower stair pre-fab started

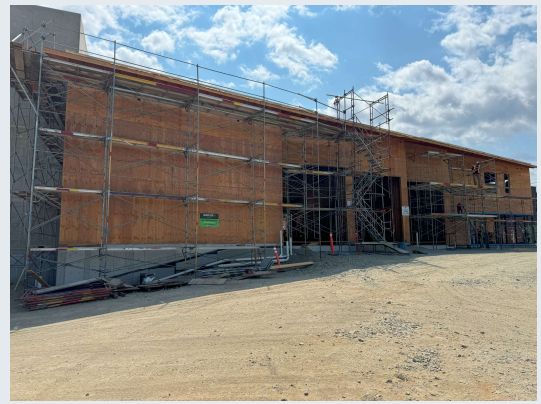
Envelope access scaffold on West progressing

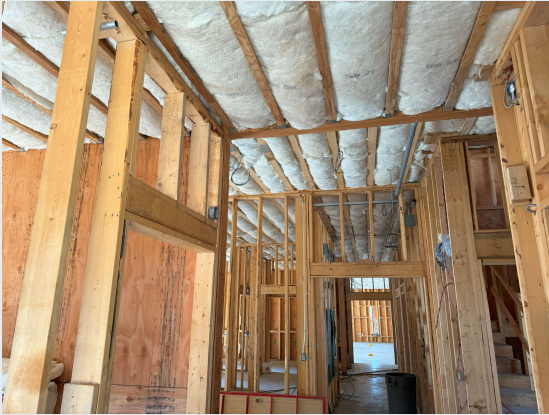
L1 South ceiling insulation complete / drywall commenced

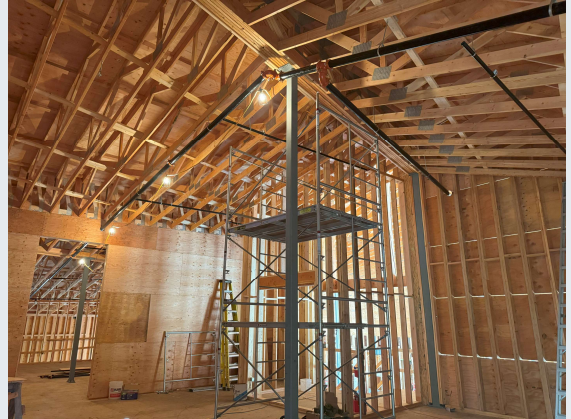
L2 North sprinkler installation commenced

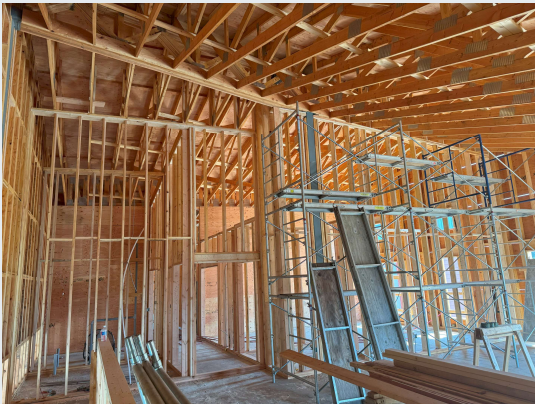
L2 South interior framing near complete

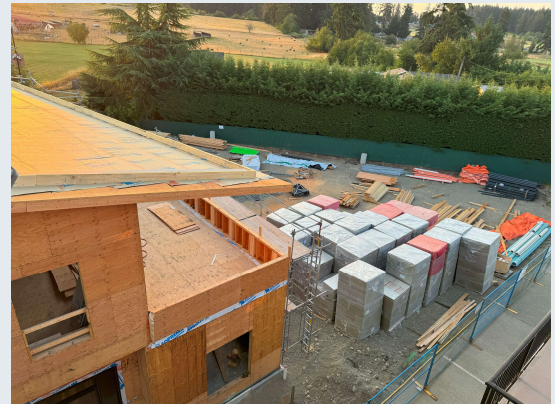
Roof insulation onsite.
